Manhole Inspection Summary

Manhole # S17W__010MH

Insp Date: **6/24/08 10:27 AM**

Location Address: **2601 washington bd**

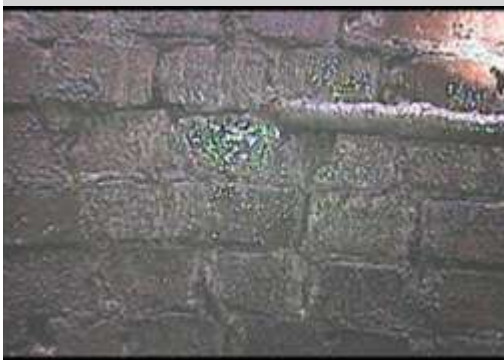
Defect 3

Infiltration: ☐ None ☐ Joint ☐ Cracks ☐ Mortar ☐ Roots ☒ **Wall**

infiltration @ corbel wall

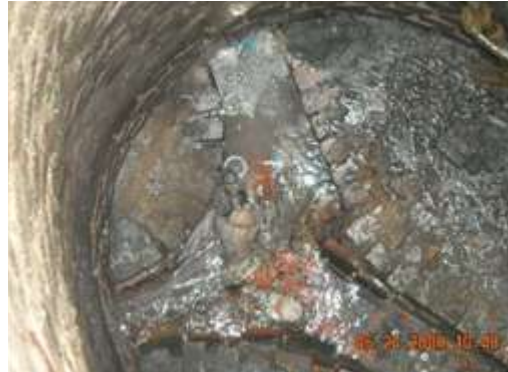
Defect 2

Condition: ☐ Sound ☐ Cracked ☐ Root Intrusion ☐ Deteriorated ☐ Leaks ☒ **Debris**

debris in channel and bench

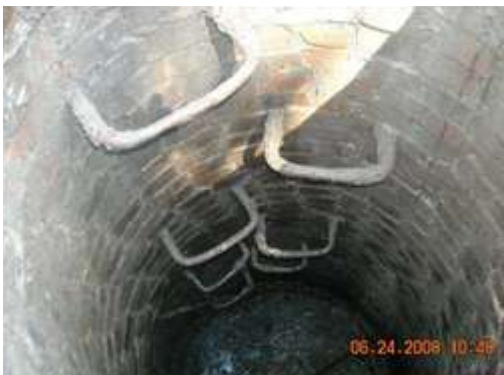
Defect 1

Count: **7** Missing: **0** ☒ **Corroded**

corroded steps

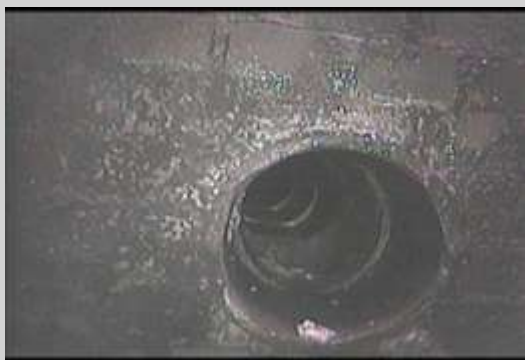
3 O'Clock Inflow

Pipe Height: **8.4** (in.) Rod and Bar (Angled)
Pipe Material: **Clay** ☐ Pipe Lined
Invert Depth: **9.00** (ft.) Flow Characteristics: **Fast**
Deposits: ☐ None ☐ Mud ☒ Sludge ☒ Debris ☐ Grease
Silt Depth: **3** (in.) Deposits Extent: **Medium**
Infiltration: **None** Pipe Seal Cond: **Sound**
